# **EVALUATION OF HIGH STRENGTH COLUMBIUM ALLOYS FOR ALKALI METAL CONTAINMENT**

**INTERIM REPORT NO. 2**

**Covering the Period  
July 25, 1962 to July 10, 1964**

**SPACE POWER AND PROPULSION SECTION  
MISSILE AND SPACE DIVISION**

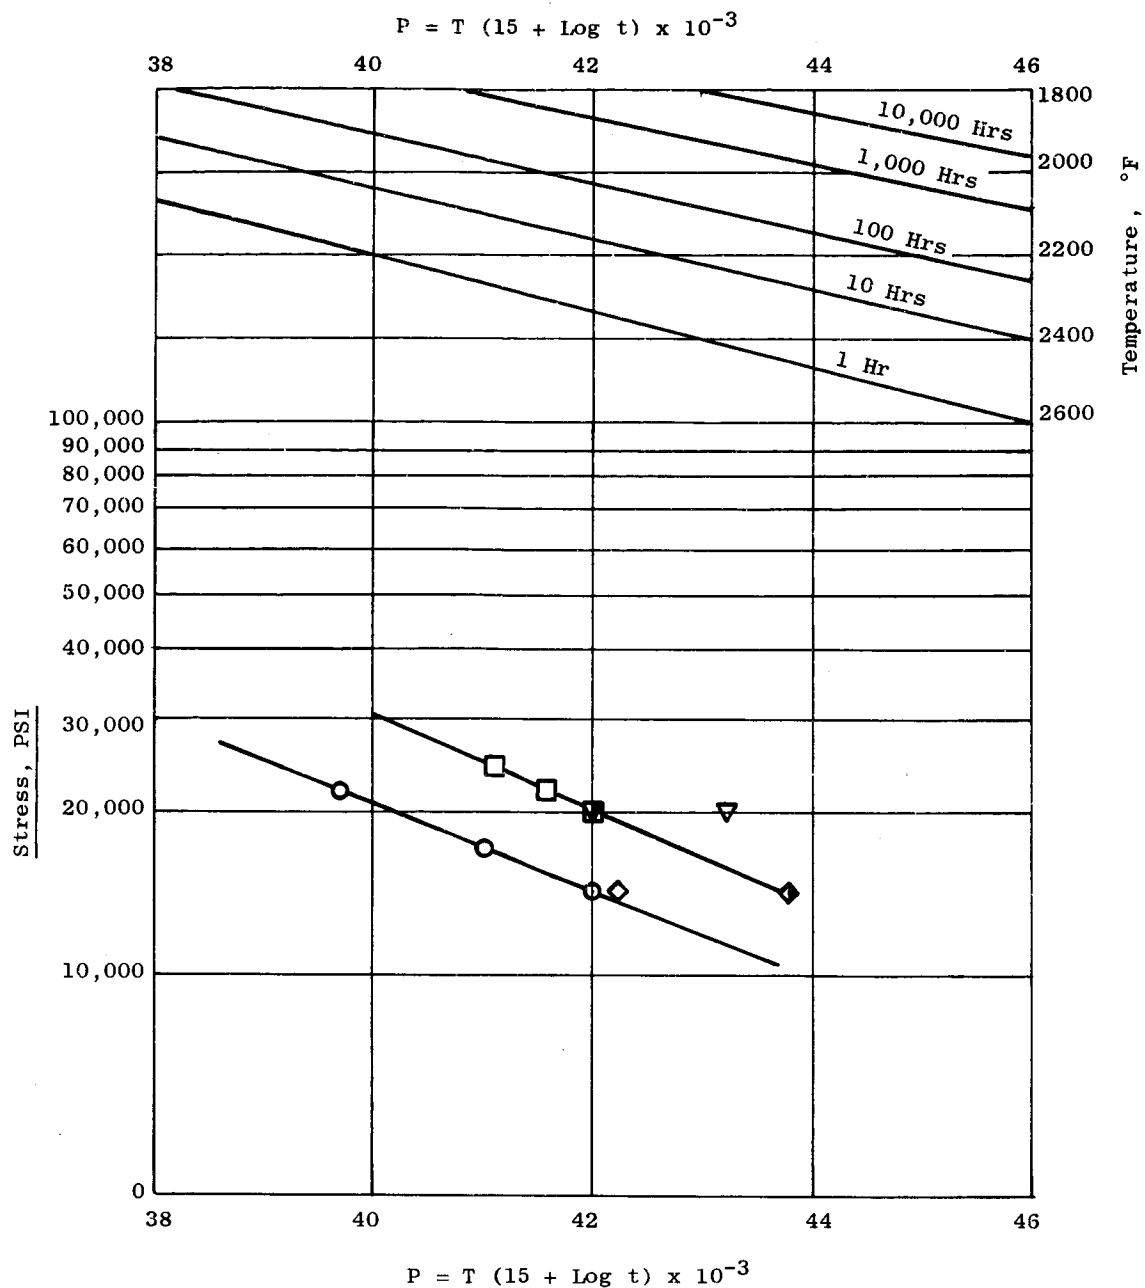
- AS-55 Alloy (NAS-5515), 0.060-Inch Thick Sheet, Heat Treated 1 Hour at 2800°F + 1 Hour at 2400°F, Rupture Tests Performed in Vacuum of  $10^{-6}$  Torr
- ◇ AS-55 Alloy (NAS-5514), Specimen Machined from Wall of Condensing Zone of Reflux Capsule #8, Rupture Test Performed in Vacuum of  $10^{-8}$  Torr
- ◆ AS-55 Alloy (NAS-5514), Specimen Machined from Wall of Liquid Zone of Reflux Capsule #8, Rupture Test Performed in Vacuum of  $10^{-8}$  Torr
- D-43 Alloy (D-43-322), 0.055-Inch Thick Sheet, Heat Treated 1 Hour at 2200°F + 1 Hour at 2400°F, Rupture Tests Performed in Vacuum of  $10^{-6}$  Torr
- ▽ D-43 Alloy (D-43-322), Specimen Machined from Wall of Condensing Zone of Reflux Capsule #2, Rupture Test Performed in Vacuum of  $10^{-8}$  Torr
- ▼ D-43 Alloy (D-43-322), Specimen Machined from Wall of Liquid Zone of Reflux Capsule #2, Rupture Test Performed in Vacuum of  $10^{-8}$  Torr

Figure 30. Stress-Rupture Properties of AS-55 and D-43 Alloy Before and After 5,000-Hour Exposure to Potassium at 2000°F in a Vacuum of  $10^{-9}$  Torr.

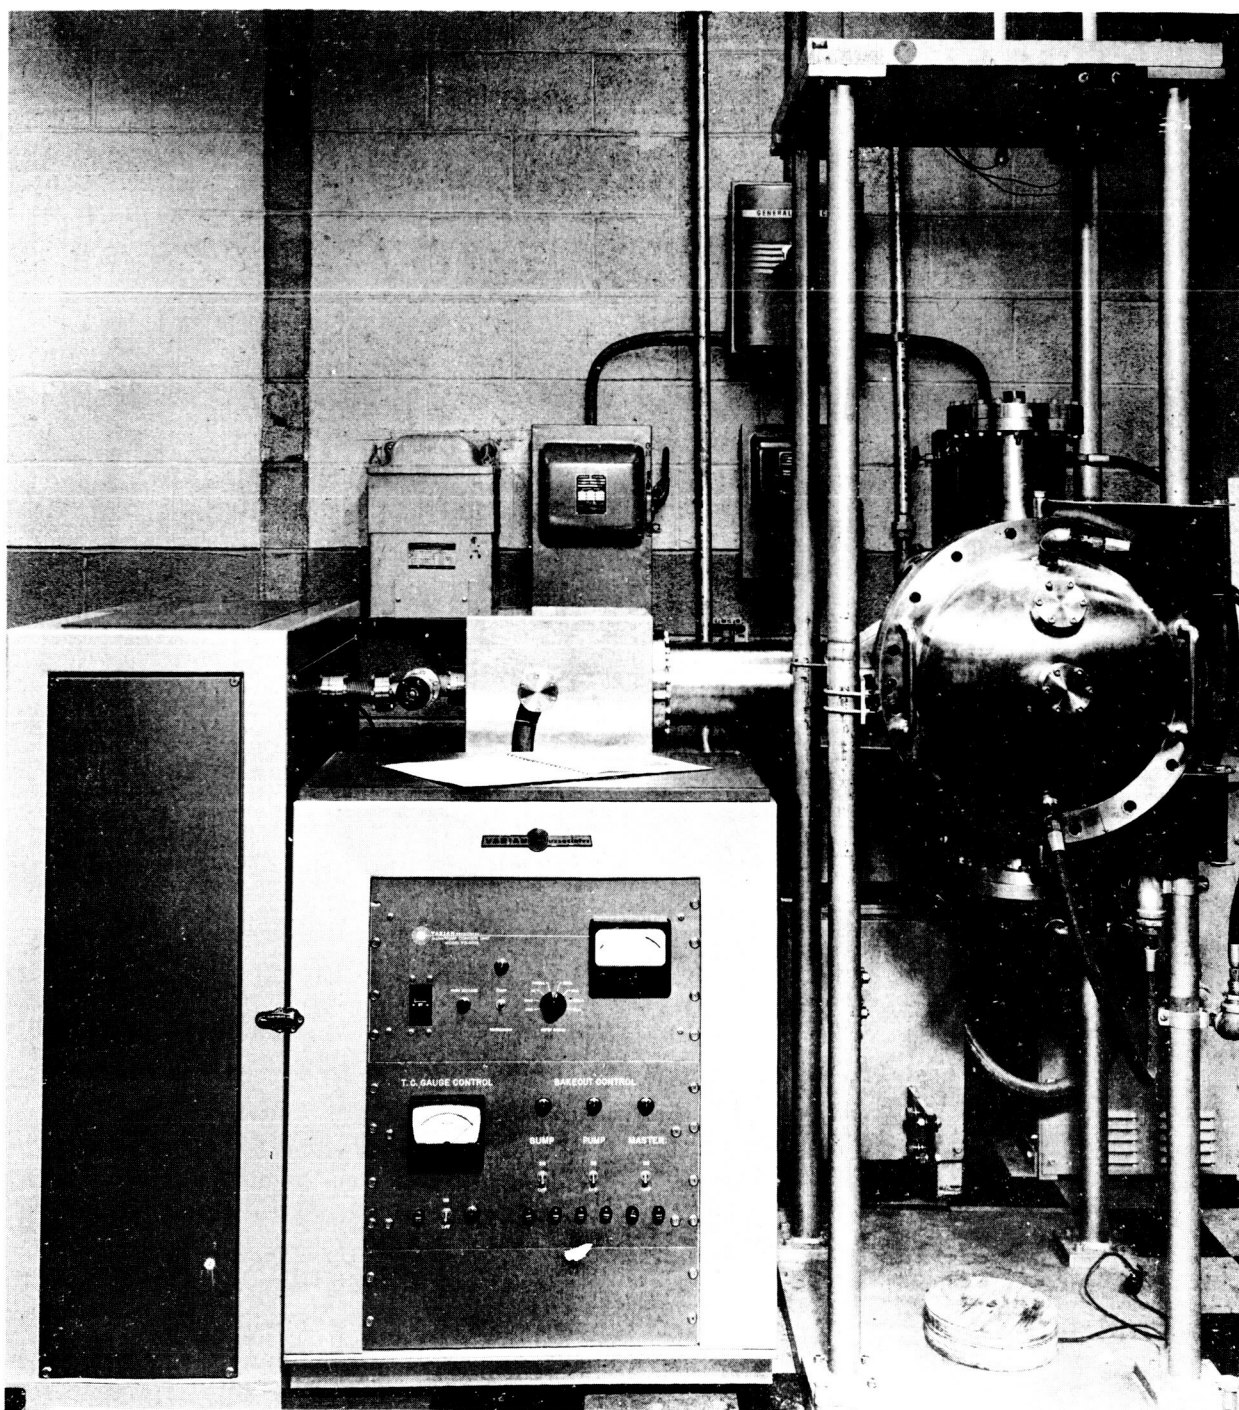
Figure 31. High-Vacuum Stress-Rupture Facility Equipped With a 400  $\text{L}/\text{Sec}$  Getter-Ion Pump and Capable of Achieving a Pressure of  $10^{-9}$  Torr. (C63020501)

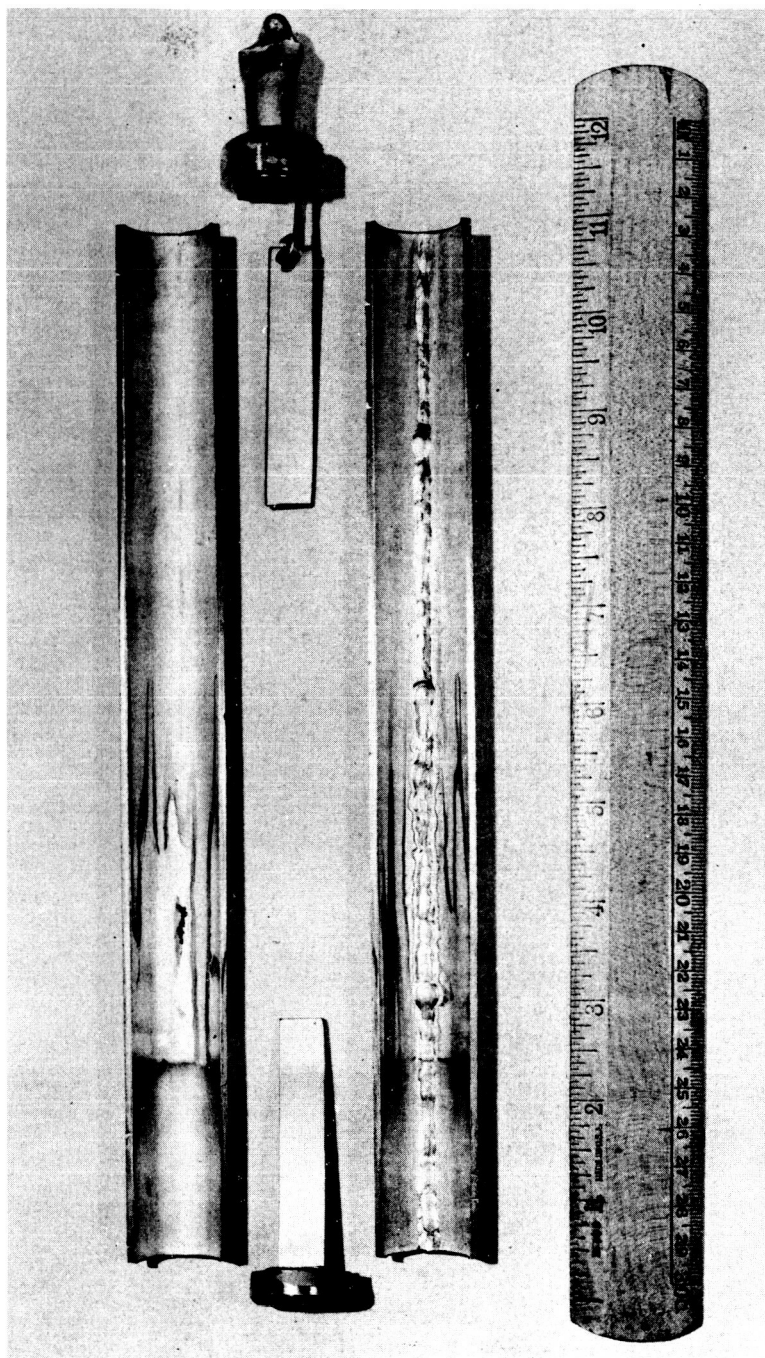
Figure 32. Sectioned Cb-1Zr Alloy Reflux Corrosion Capsule #7  
After a 10,000-Hour Exposure to Potassium at 2000°F  
in a Vacuum of  $10^{-9}$  Torr. (C63122633)

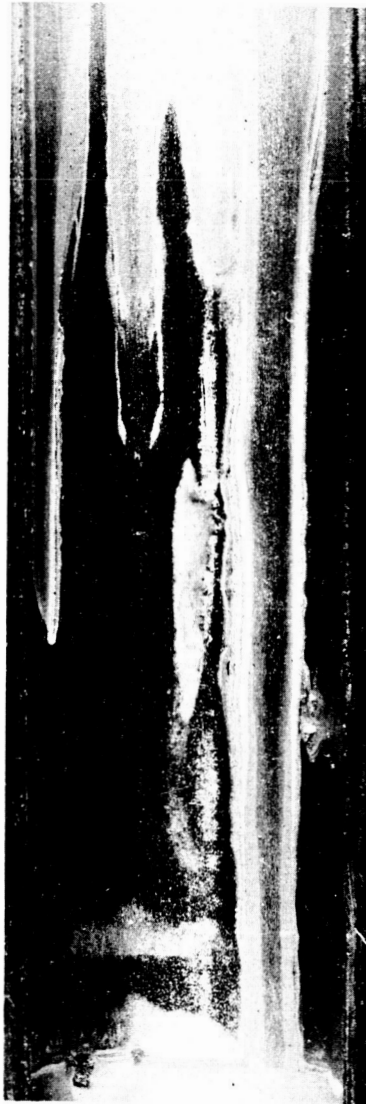
Mag: 2X (C63122625)

Figure 33. Black Deposits and Discoloration Observed on the Inner Surface of Cb-1Zr Alloy Corrosion Capsule #7 Between the Primary Condensing Zone and the Liquid Zone After a 10,000-Hour Exposure to Potassium at 2000°F in a Vacuum of  $10^{-9}$  Torr.

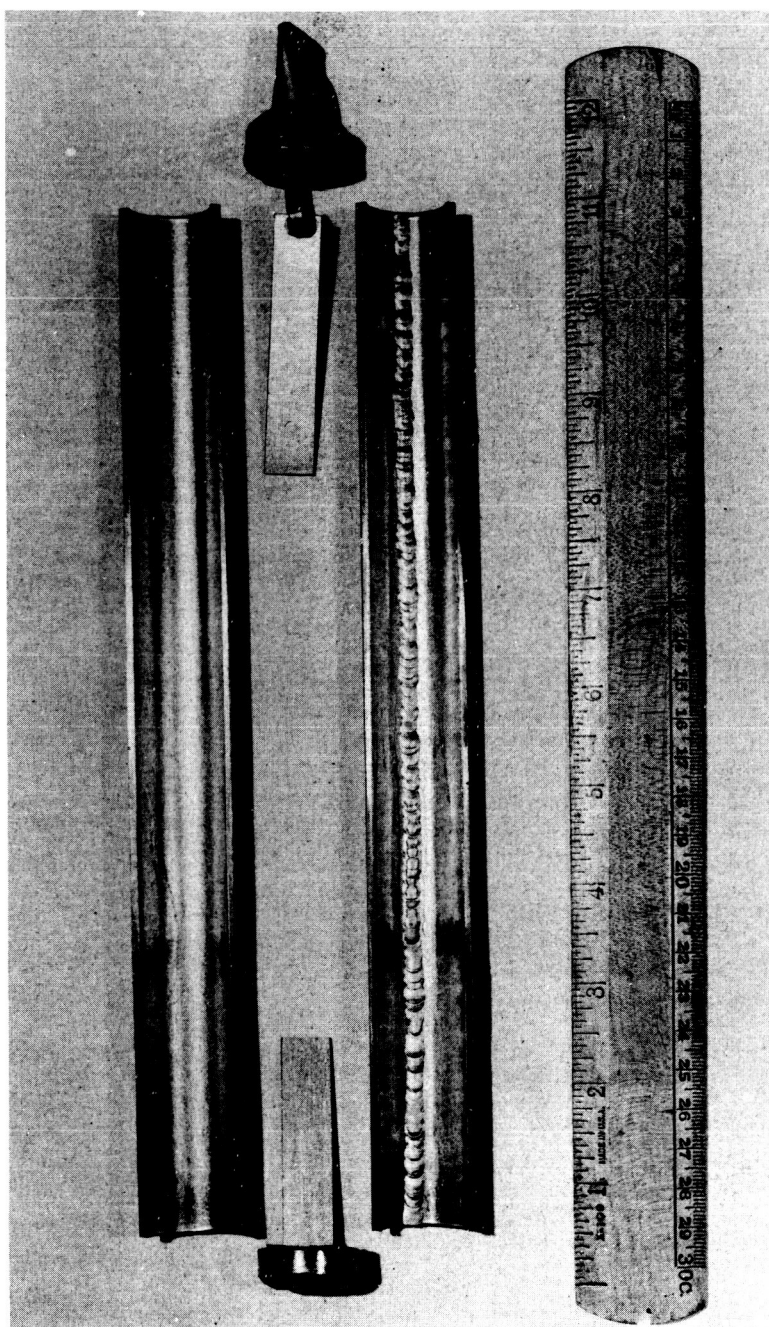
Figure 34. Sectioned AS-55 Alloy Reflux Corrosion Capsule #9  
After a 10,000-Hour Exposure to Potassium at 2000°F  
in a Vacuum of  $10^{-9}$  Torr. (C63122632)

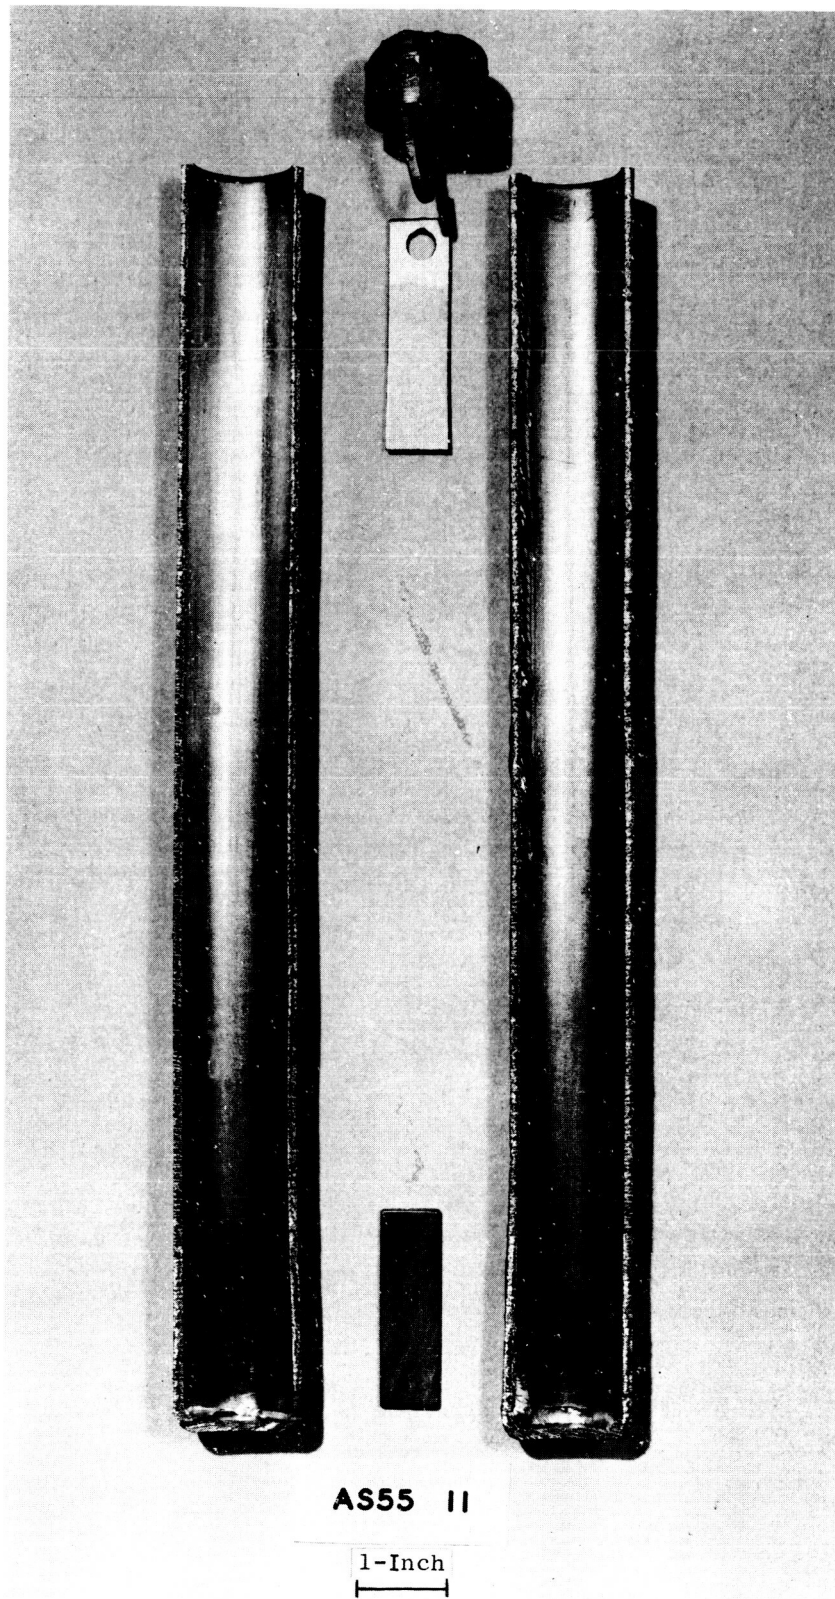
Figure 35. Sectioned AS-55 Alloy Reflux Corrosion Capsule #11  
After a 10,000-Hour Exposure to Potassium at 2000°F  
in a Vacuum of  $10^{-9}$  Torr. (C64091109),

AS-55 alloy capsule #11, which was filled with potassium using the vacuum filling facility discussed earlier, showed no discolorations in the region just above the liquid zone, Figure 35. However, white deposits, which were similar to those seen previously in the 5,000-hour AS-55 alloy capsule #12, were found in three locations on the inside surface of the AS-55 capsule #11; two in the liquid region and one in the vapor region. Figure 36 shows the white deposits that formed on the weld in the liquid zone and Figure 37 shows a deposit on the parent metal in the liquid region opposite

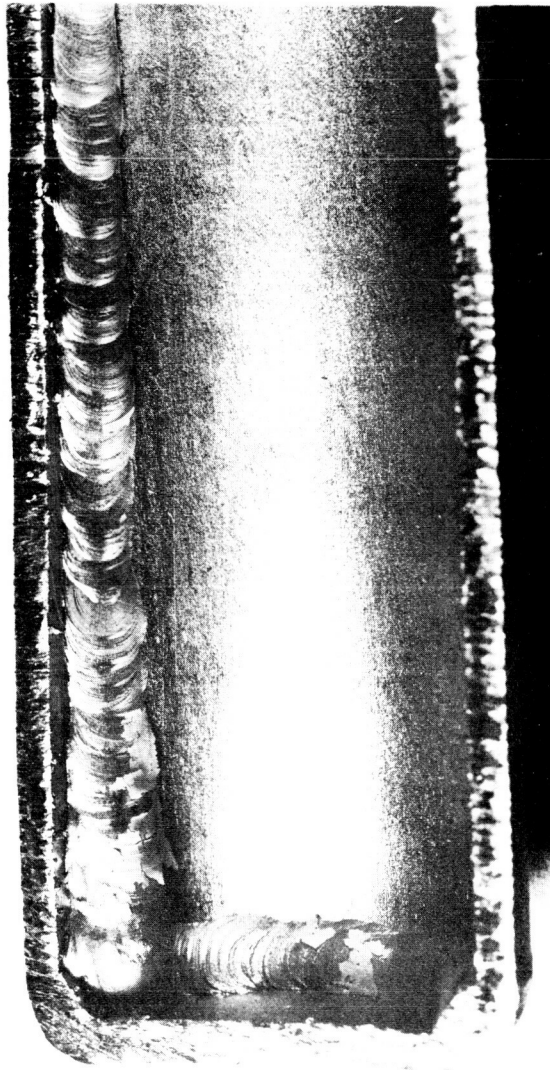
Figure 36. White Deposit Found in Weld in Liquid Zone of AS-55 Alloy Reflux Capsule #11 After a 10,000-Hour Exposure to Potassium at 2000°F in a Vacuum of  $10^{-9}$  Torr.  
Mag: 3X (C64091112)

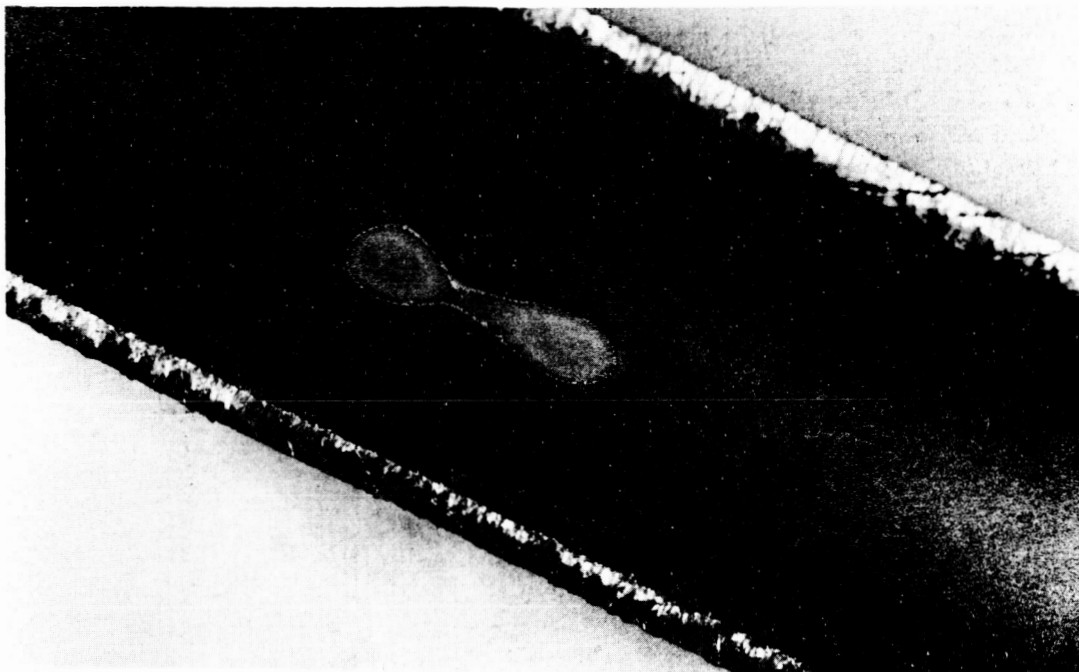
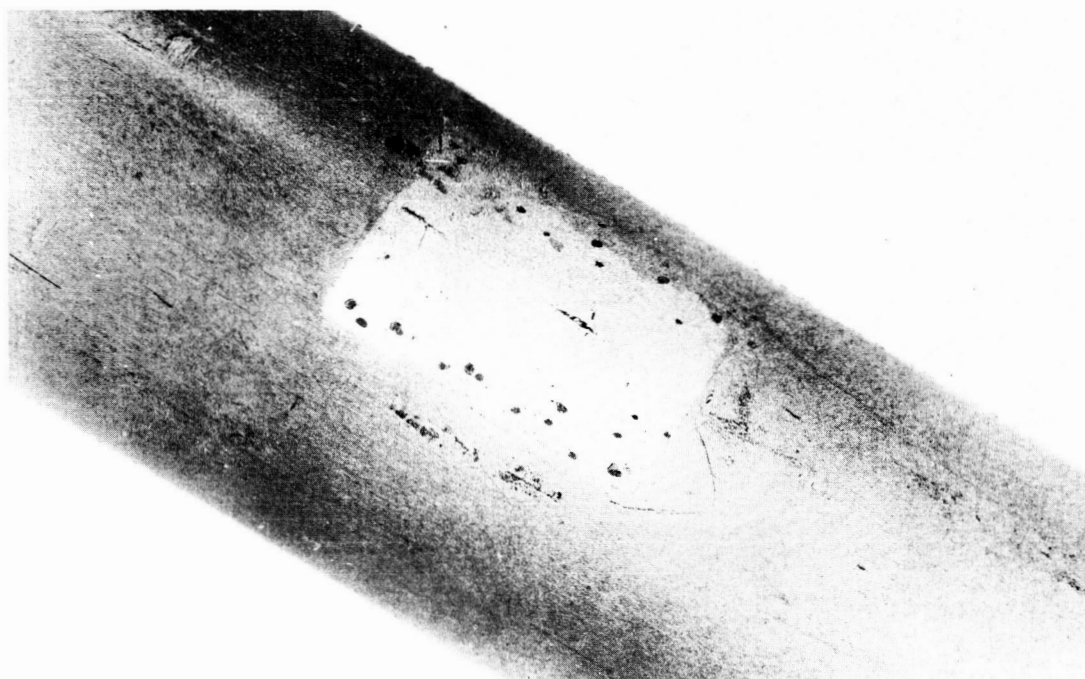
Figure 37. White Deposits Found on the Inside Surface of AS-55 Alloy Reflux Capsule #11 in the Liquid Zone (Top) Opposite the Location Where a Thermocouple was Attached to the Capsule Wall (Bottom). The Capsule was Exposed to Potassium for 10,000-Hours at 2000°F in a Vacuum of  $10^{-9}$  Torr. Note Bonding of Tantalum Sheath of Thermocouple to Capsule. Top: Mag: 3X (C64031113); Bottom: Mag: 3X (C64031111).

the point where a thermocouple was in contact with the capsule wall. Although the majority of the deposited material was found in the liquid region, one small deposit was found in the vapor region. In previous capsules, i.e., 5,000-hour tests, similar deposits have been observed only in the liquid zone. Identification of the deposit in capsule #11 is currently under way. However, it is postulated that the deposit is  $Y_2O_3$  which is formed by the oxidation of yttrium in the potassium and on the surface of the capsule wall. The primary mechanism which is believed to account for the presence of  $Y_2O_3$  at localized areas on the capsule wall assumes the existence of localized areas in the capsule wall that can provide a relatively large source of oxygen, resulting in the oxidation of yttrium that is in solution with the potassium at these specific locations. In the case of the weld metal, a high oxygen concentration could exist due to contamination during the welding operation. The presence of a high oxygen concentration in localized spots in the parent metal opposite thermocouple junctions is most likely due to diffusion of oxygen from the thermocouple insulation resulting from non-stoichiometry, entrapment of air during swagging or from impurities in the  $Al_2O_3$ . Because of the latter possibilities, the use of bare thermocouple wires is recommended.

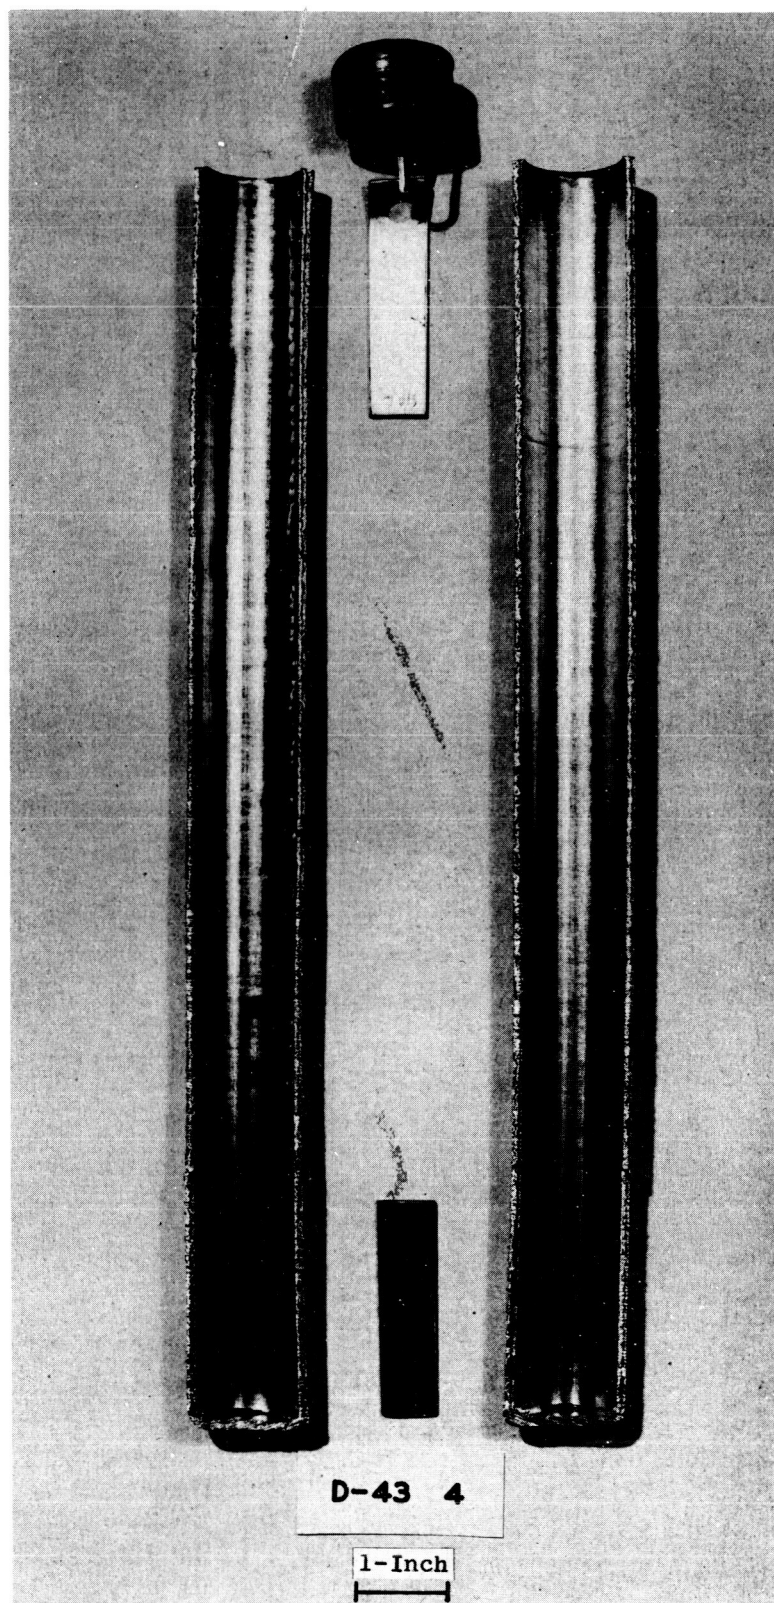
Figure 38. Sectioned D-43 Alloy Reflux Corrosion Capsule #4  
After a 10,000-Hour Exposure to Potassium at 2000°F  
in a Vacuum of  $10^{-9}$  Torr. (C64091110)
